Flexural Capacity of Corroded Post-tensioned Concrete Beams: Large Scale Tests and Numerical Simulation

Antonino Recupero^{*,a}, Nino Spinella^b, Antonio R. Mari^c, Jesús M. Bairán^d

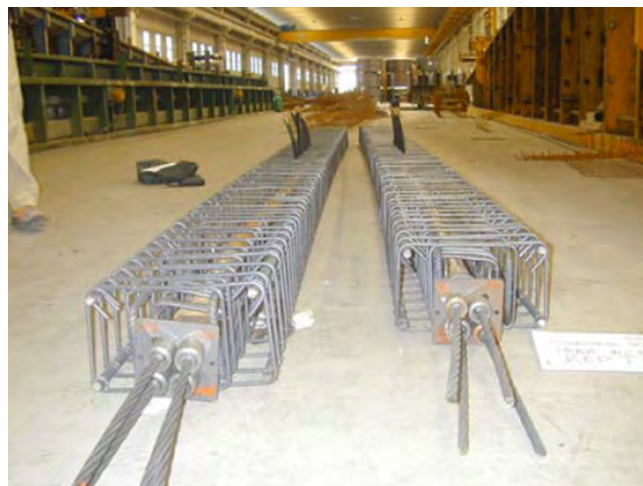
The PC specimens had a rectangular shape (400×250 mm) and a total length of 6300 mm. Prestressing was carried out using 4 tendons of 7-wire 0.6" strands, and steel with an ultimate tension capacity of $f_{ys} = 1860$ MPa was used. The cable was placed along the centroid axis (figura 1). The longitudinal reinforcement was achieved with $2\phi 18$ both at top and bottom of the cross-section. The transverse reinforcement was realized with closed stirrups $\phi 8/100$ mm, except for a closest spacing (80 mm) at the ends of the beam and for a transfer length of

800 mm (figura 1). The FeB44k steel rebar was used, with a minimum yield strength of 430 MPa.

Figure 1. Reinforcement setup.

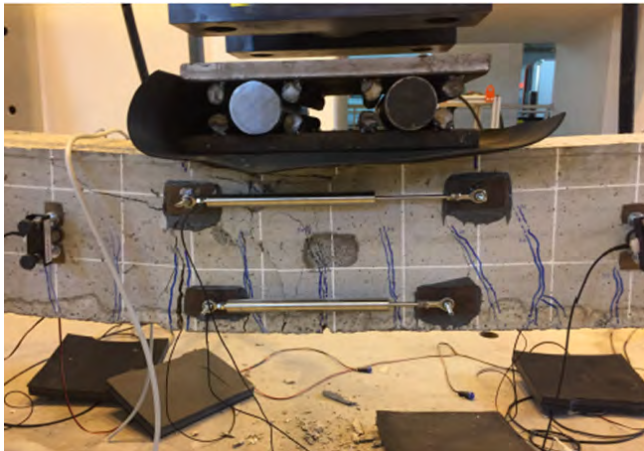
In figure 3, the crack pattern at failure of the region under the load point is reported. It is typical of the bending failure. The top region of the beam has been characterized by crushing of concrete in compression, which has led to the failure.

Figure 3. Crack pattern at failure of beam T1.

The response behavior was almost linear until the load level of 100 kN. Then, a stiffness decay was observed, with a soft slope of the curve. The cycle at 130 kN allowed to achieve the maximum load bearing capacity of the beam, and a fast drop of the beam at the mid-span was occurred.

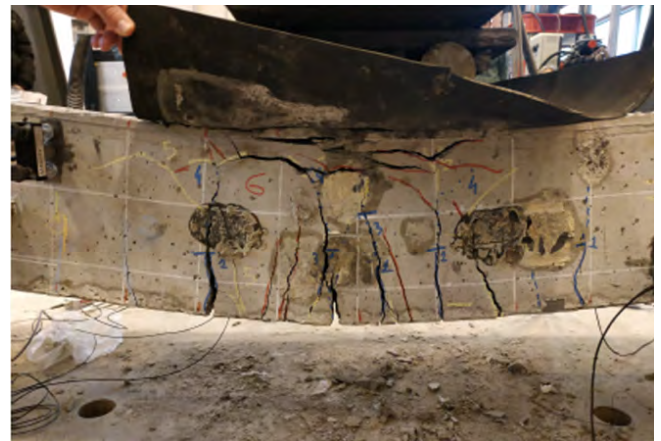
The response behavior has been also linear until a maximum load of less than 60 kN, see figure 5.

Figure 5. Crack pattern at failure of beam T3a.

It is almost half of the bearing load achieved by the T1 beam. At the fourth cycle the maximum load bearing capacity of the beam (about 60 kN) has been recorded. The force peak has been followed by a load abruptly decay, and a typical noise of steel breaking has been heard. Probably a strand broke or frayed, in fact the next cycles have been characterized by both lower stiffness and load, with subsequent drops of force. The corrosion in the middle of the tendon has drastically changed the capacity of the beam.

The beam T3a was damaged with a hole inside of the duct at 1/2 of the beam length. A chemical solution was injected in the small tank, 100 mm long, to cause a localized corrosion of the tendon. The test was performed under displacement control, and seven cycles were executed at the following displacement levels: 10, 20, 40, 60, 80, 100 and 140 mm.

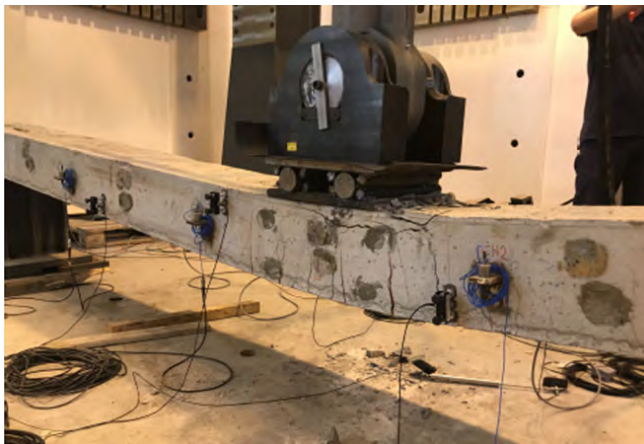
The response behavior has been almost linear until a load less than 50 kN. At the fourth cycle, the stiffness decay, and the load-displacement curve showed a new branch with different slope. The last cycle has allowed to achieve the maximum load bearing capacity of the beam (more than 60 kN), followed by two subsequent drops of force.

Figura 6. Crack pattern at failure of beam T4a.

This specimen was damaged with a hole inside of the duct at 1/4 of the beam length. A chemical solution was injected in the small tank, 100 mm long, to cause a localized corrosion of the tendon.

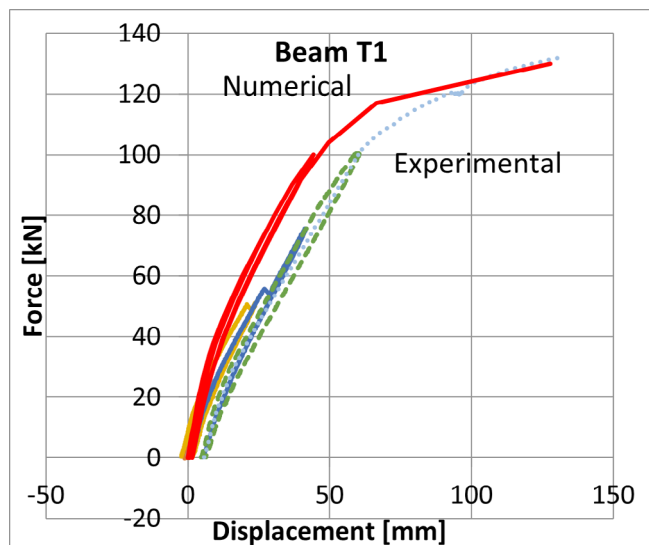
Figure 10 shows the experimental and numerically obtained load-deflection curves of beam T1, without induced corrosion.

Figure 10. Load-displacement curves, beam T1

Load control was used in this test, for the six loading and unloading cycles until reaching 25, 50, 75, 100, 130 and 150 kN. The ultimate load found was 130 kN, therefore, only 5 cycles are represented in figure 10. It is observed that the ultimate capacity is very well captured by the numerical model, although the experimentally measured deflections were higher than those numerically obtained.

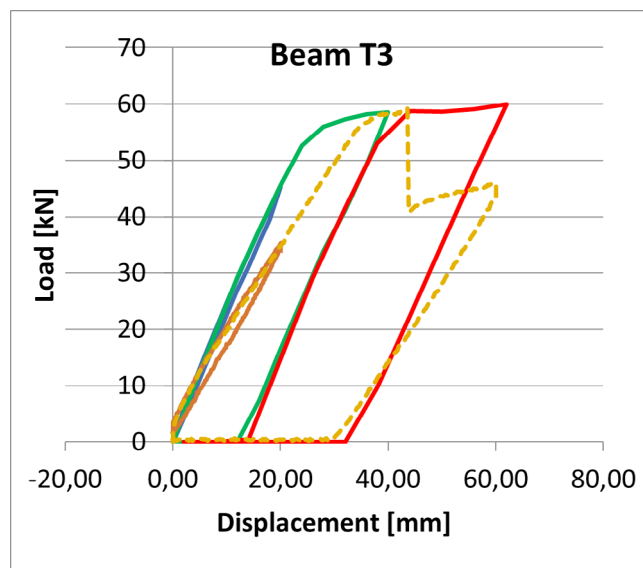
Beam T3 was corroded in a portion of 1 m length placed at mid-span of the beam. The test was performed under imposed displacements, unloading until zero load was reached, for each cycle. Figure 11 shows the theoretical and the experimentally measured load-deflection curves

It can be observed that the ultimate capacity has been well captured by the numerical model, but there are differences in the shape of the load-displacement curves. The experimental curve shows a lower stiffness and, in addition, a sudden drop of capacity for an imposed displacement of 50 mm,

Figure 11. Load-displacement curves, beam T3a.

probably due to the break of a wire. Such phenomenon has been not captured by the model, since the constitutive equation of the steel has not been modified as consequence of the corrosion.

In particular, for the tested beams, the reduction of the ultimate load has reached almost 50% with respect to the un-corroded beam. The displacements for the ultimate load were reduced from $L/20$ for the uncorroded beam to $L/42$ and $L/85$ for the corroded beams T3 (corrosion at midspan) and T4 (corrosion at $1/4$ length), respectively.

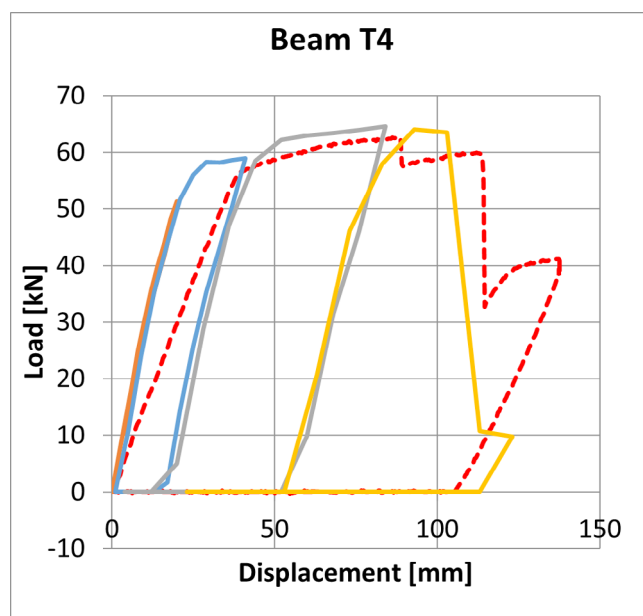
Beam T4 was damaged by injecting a chemical solution in a length of 100 mm long, at 1/4 of the length (symmetrically) to cause a localized corrosion of the tendon. The test was performed under displacement control, by means of 6 cycles of 10, 20, 40, 80, 100 and 200 mm, respectively. The ultimate load reached experimentally was 62.3 kN for a displacement of 85 mm, while the numerical model has predicted 64.5 kN for a displacement of 84 mm. Again, the experimental results showed a lower stiffness, although the predictions are quite coincident with the experimental results, as shown in figure 12.

Figure 12. Load-displacement curves, beam T4
